## QUALITATIVE ASSESSMENT OF THE DEFECTS IN METAL CASTING PROSTHETIC RESTORATIONS

Joanna Augustyn-Pieniążek<sup>1</sup>, Kamil Wilkosz<sup>2</sup>

**Keywords:** Cobalt-based alloys, casting defects, dental prosthetics, 3D scanner

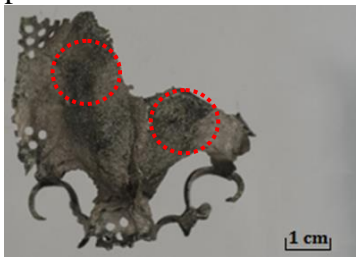
**Fig. 1.** Cast of a frame bracket prosthesis with a visible casting defect in the form of blisters

One of the causes of the formation of shape defects is an improperly designed gating system. A frequent cause of the occurrence of casting defects is an inappropriate location of the ingates, which generates strong perpendicular strikes of the liquid metal at the walls of the mould. That is why, in the areas where there is a risk of a mould cavity deformation, the ingates should be situated at an angle in respect of the mould cavity.

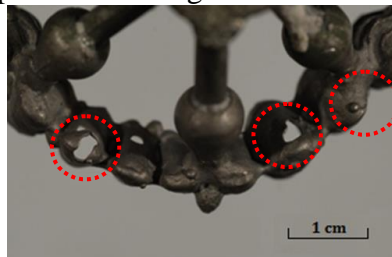
**Fig. 2.** Structure of a circular bridge with casting defects in the form of blisters and misruns in the upper and side part of the substructure

An earlier solidification of the metal causes an incomplete fill-up of the mould, which results in the presence of defects such as a misrun of the material. The occurrence of a misrun is, to a large degree, caused by an insufficient castability of the metal. A defect of this type can also be caused by an insufficiently high temperature of the metal (which should be controlled throughout the whole technological process), a badly selected chemical composition or a thickness of the cast walls too low in respect of its height.

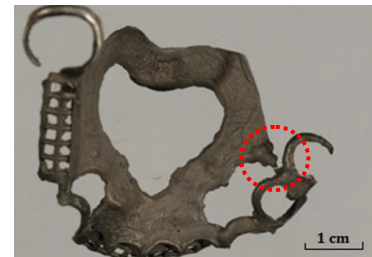
**Fig. 3.** Frame prosthesis with a visible cold fracture on the side of the bracket

A cold or hot crack of the material is a result of a temperature difference in the cross section, which generates shrinkage stresses formed during the solidification process. The formation of this type of defects may also occur when the knock-out of the cast from the metal mould is too rapid or the content of gases in the metal which are formed in the alloy during its casting or during the mould filling process is too high. Too high an amount of non-metallic inclusions as well as their disadvantageous form also negatively affect the quality of the cast.

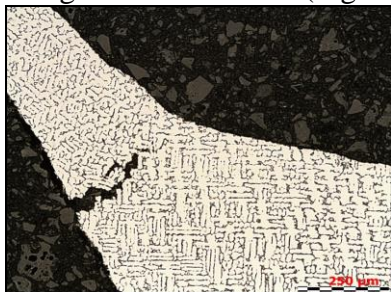
**Fig. 4.** Microstructure of the Co-Cr-Mo alloy with a visible casting defect – intercrystalline crack

In the solidification process, the casting stresses present in the material generate not only external defects but also structural ones. An intercrystalline crack is the main defect of centrifugally cast materials. It is a fracture running between the grains of the alloy. Its main cause is an improper course of the metal's solidification process. Another internal defect which can be present in the cast is a blister. The main factor for the occurrence of blisters is the gas released from the moulding sand as well as the gas released from the metal during its solidification. In order to eliminate the causes of the defect, one should assure a proper degasification and purification of the metal

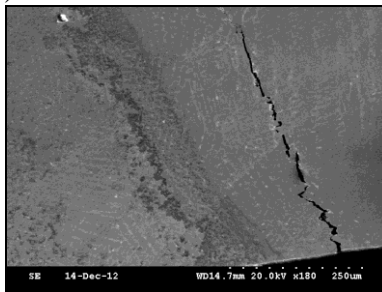
The microscopic and SEM observations confirmed the presence of cast defects in the form of microshrinkages and pores occurring in the dendrite arms as well as microcracks running along the dendrite axis (Fig. 4-5).

**Fig. 5.** Scanning images with visible casting defects in the form of microshrinkages and pores as well as cracks, with different magnifications
